**FORENSIC ENGINEERING ANALYSIS OF BUILDING STRUCTURES IN INDONESIA:
A CASE STUDY OF THE COLLAPSE OF THE MAHAKAM II KUTAI KARTANEGARA
BRIDGE IN EAST BORNEO**

Kamaluddin*, Researcher

National Institute of Technology, Malang, East Java, Indonesia

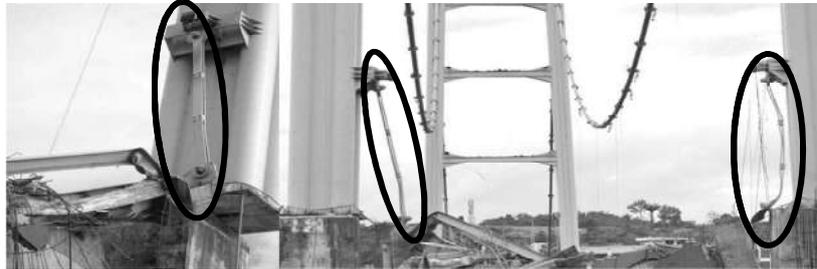
Figure 3 – Tower Strap as a Binder for Direct Bridge Frame in Steel Pylon

The reconnaissance survey found a type of structural component in the form of a pull rod that was used as a hanging bridge frame directly to pylons (not through suspension cables, see Figure 11). This structural component is called a tower strap (TS). The dimensions of the tower strap are large enough so that the stiffness is also greater than a standard hanger. The pedestal nature of the tower strap is a roller in a small deviation; however, it can turn into a joint at a larger junction. In the vertical direction the movement of the bridge frame is locked due to the tower strap, while the lateral direction is restrained by the stopper.

The presence of a tower strap on both pilons has 'locked' the vertical frame of the bridge. Tower strap is the cause of stiffness discontinuity, which causes the emergence of primary and secondary moments in the pylon area. The decambering movement of about 20 cm due to shifting of anchor blocks and an additional about 40 cm due to the work of a total load of about 60 cm in the main span was not successfully distributed smoothly throughout the landscape due to the 'lock' effect in the Pylon area and the presence of a tower strap. This results in the growth of an additional tensile force in the upper stem, an additional tensile/ compressive force on the diagonal rod, and an additional compressive force on the rootstock in the pylon area, and triggers local instability resulting from breaking of the pulling bolts, failure to pull/ press diagonal rod, or bend on the press rod. The local instability is expected to occur in structural components in the Tenggara side pylon area downstream between the tower strap and the first interior hanger. The local instability propagates progressively and becomes a global instability which has caused catastrophic failure. The existence of a tower strap has been the main cause of the collapse of the Kutai Kartanegara Bridge.

The tower strap is a massive size hanger that is used to hang bridge frames directly into the pylon. The existence of a strap tower has disrupted the internal force distribution of the components of the bridge frame structure. In addition, it is revealed that the tower strap has caused failure in four of the five scenarios.

In a scenario without a tower strap and frame, there is no bridge failure, even though the tensile force near the pylon increases due to the removal of the tower strap. The existence of a tower strap has caused great internal forces on the components of the bridge frame structure that is nearby. This is not found when the tower strap is removed. In fact, in one scenario, the bridge condition seems to be quite stable if the tower strap is removed even though the anchor block shift occurs. Thus, it can be stated that the tower strap is the main cause of bridge collapse.

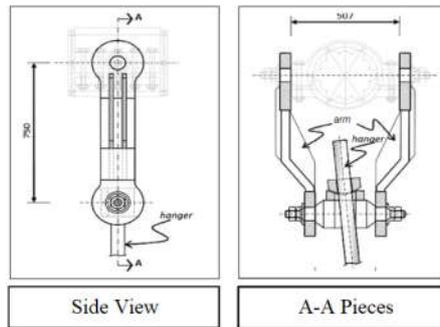
Figure 4 – Cable Bands of the Kutai Kartanegara Bridge

It is not experienced by all remaining points that are attached to the hanger. Cable band is commonly used on suspension bridges as a connecting component between hanger and suspension cable. At the Kutai Kartanegara Bridge, the components are not cable bands as they are commonly used. However, to facilitate the discussion in this paper, these components are still referred to as cable bands. The cable bands component is shown in Figure 4.

Another cause of the collapse is the occurrence of slip on some cable bands before the incident. The slipped cable bands are observed at a location near the pylon. The vertical component of the slip has a decambering effect that is quite destructive because it is near the Pylon where the decambering effect cannot be distributed smoothly in the area due to the presence of a tower strap. The decambering effect on the Pylon area has contributed to local instability and the derivative effects as previously stated.

Based on the calculation results, the slip cable band on the suspension should not have occurred. However, the facts of the field indicate the existence of the slip; especially for cable band near Pylon. Slip cable band can occur due to the increased load on the hanger that occurs due to the relaxation process on the other hanger next to it. Slip cable headbands can result in decambering and secondary pull/ press forces on the upper/ lower/ diagonal trusses of the bridge frame. If the force is too large, it can break the bolts at the top/ diagonal joint, or cause bending on the lower/ diagonal rod, and trigger local instability. Local instability can progressively lead to global instability and cause catastrophic collapse.

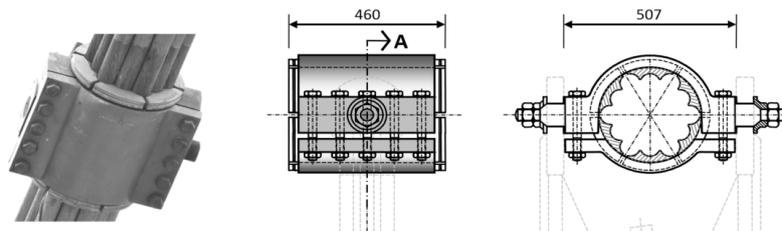
Figure 5 – Clamp and Hanger Used on the Bridge

At the Kutai Kartanegara Bridge, the connection between the hanger and cable bands is done through clamps. Generally, this clamp consists of a pair of arms. The upper part of the arm is connected to a band through an arch that protrudes on both sides of the band. Meanwhile at the bottom, a pair of clamping arms is connected by an arch. The arch is where the hanger is based; which is right in the middle of the arch. The clamping arm material is made of FCD 60 cast iron (Ferro Casting Ductile), with strong melting $f_y = 370$ MPa, tensile strength $f_u = 600$ MPa, and 3% spreading. Hanger is made of steel material with strong melting $f_y = 555$ MPa and tensile strength $f_u = 700$ MPa. Field observations show that all hanger has shown satisfactory performance; as in the case of suspension cables. There are very few hangers that are found broken in brittle mode, even though there are many crooked hangers. The hanger is made of round steel rod with screw on the outside; hanger stem diameter is 63 mm. The screw is used as a means of connecting the hanger to the clamp or to the bridge frame bracket. In certain parts there is a coupler as a means of connecting between hangers.

There are at least six instructions that indicate that the clamp has adequate resistance. However, the clamp design that tends to be complicated in terms of load transfer has caused clamping resistance to be determined by its stability. In a normal configuration, according to the initial design, the clamp will be quite strong. However, if the clamp must carry the hanger's pulling force on its side, the resistance will be greatly reduced. The sloping state occurs when the suspension cable moves transiently and the bridge frame is in a highly distorted geometry when it falls into the river. Regarding the relatively low stiffness of the suspension cable torque, two successive clamps can experience different angles when there are torsional waves propagating on the suspension cable. This can also reduce clamping resistance significantly.

If the modified clamp design becomes more reliable, it can avoid progressive collapse even if a partial failure occurs in one of the clamps/ hangers. Furthermore, it is found that if there is a failed clamp, the failure of the clamp is more likely to occur in the clamp or hanger near the pylon than the clamp or hanger in the middle of the span.
