**FORENSIC ENGINEERING ANALYSIS OF BUILDING STRUCTURES IN INDONESIA:
A CASE STUDY OF THE COLLAPSE OF THE MAHAKAM II KUTAI KARTANEGARA
BRIDGE IN EAST BORNEO**

Kamaluddin*, Researcher

National Institute of Technology, Malang, East Java, Indonesia

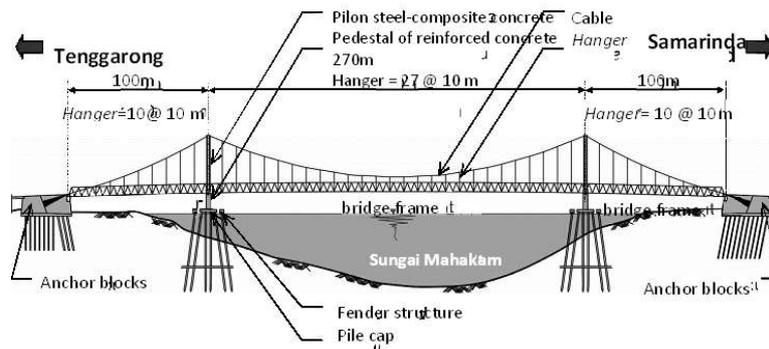
Figure 2 – The Main Components of Mahakam II Kutai Kartanegara Bridge in Tenggarong

The bridge frame is used as a stiffening girder which also carries directly the floor of the vehicle. The bridge is generally in the form of a steel space truss which consists of plane trusses which are stretched with a girder that crosses a 5-meter sphere at the bottom, and wind bonds at the top. The bridge frame is given a camber which changes slowly from zero at both ends to approximately 3.8 meters in the middle of the span.
